# WOOD DESTROYING PESTS AND ORGANISMS INSPECTION REPORT

Building No. 15500	Street BODEGA HIGHWAY	City OCCIDENTAL	Zip 95465	Date of Inspection 08/17/2017	Number of Pages 6
-----------------------	--------------------------	--------------------	--------------	----------------------------------	----------------------

Report # : 18116  
 Registration # : PR5356  
 Escrow # :  
 CORRECTED REPORT

GENERAL DESCRIPTION: TWO STORY SINGLE FAMILY RESIDENCE, WOOD FRAME, STUCCO EXTERIOR	Inspection Tag Posted: Garage <hr/> Other Tags Posted: NONE CURRENT
--	--

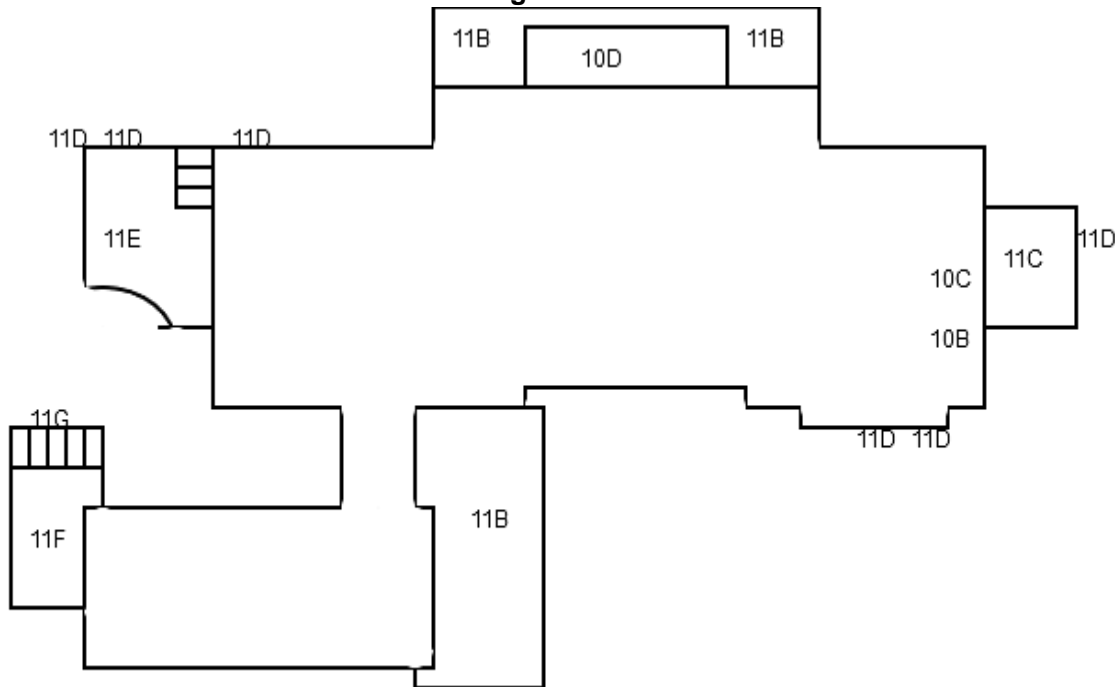
**Diagram Not To Scale**

STAINING WAS NOTED ON THE DOORS AND WINDOWS IN THE ENCLOSED SUN ROOM AT "10D"" ON THE DIAGRAM.

THE TRELLISES AT "11B" ON THE DIAGRAM WERE NOTED TO BE OPEN AND EXPOSED TO EXTREME WEATHER. VEGETATION WAS NOTED GROWING ON TOP OF THE TRELLISES. ROT DAMAGE WAS NOTED IN THE TOP OF THE TRELLISES. THE EXTENT OF ROT DAMAGE COULD NOT BE DETERMINED AT THE TIME OF THIS INSPECTION.

THE DECK AND TRELLIS AT "11C" ON THE DIAGRAM WERE NOTED TO BE OPEN AND EXPOSED TO EXTREME WEATHER. ROT DAMAGE WAS NOTED IN THE TOP OF THE DECK. VEGETATION AND MOSS WERE NOTED GROWING ON THE TRELLIS. ROT DAMAGE WAS NOTED IN THE TOP OF THE TRELLIS.

SUBAREA ACCESS DOORS HAVE BEEN LEFT OPEN AND SUBAREA SCREENS HAVE BEEN TORN AT "11D" ON THE DIAGRAM. ANIMALS ARE ENTERING THE SUBSTRUCTURE FROM THESE AREAS.

THE DECK AT "11E" ON THE DIAGRAM WAS NOTED TO BE OPEN AND EXPOSED TO EXTREME WEATHER. ROT DAMAGE WAS NOTED IN THE TOP OF THE DECK. ROT DAMAGE WAS NOTED IN THE ACCESS OPENING. THE UNDERSIDE OF THE DECK WAS INACCESSIBLE FOR INSPECTION DUE TO THE ANIMALS.

ROT DAMAGE WAS NOTED IN THE STAIRS AT "11G" ON THE DIAGRAM.

ANY ALTERATIONS MADE TO THE DOORS AND WINDOWS, AT THIS TIME, WOULD BE OF COSMETIC NATURE AND LEFT TO THE DISCRETION OF THE BUYER AND SELLER.

OWNER IS ADVISED TO HIRE AN APPROPRIATE TRADES PERSON TO POWER WASH THE TRELLISES, MAKE FURTHER INSPECTION AND REMOVE AND REPLACE ALL ROT DAMAGED WOOD MEMBERS FOUND.

OWNER IS ADVISED TO HIRE AN APPROPRIATE TRADES PERSON TO POWER WASH THE TOP AND UNDERSIDE OF THE DECK, POWER WASH THE TRELLIS, MAKE FURTHER INSPECTION AND REMOVE AND REPLACE ALL ROT DAMAGED WOOD MEMBERS FOUND.

OWNER IS ADVISED TO REMOVE ALL ANIMALS FROM THE SUBSTRUCTURE, REPAIR AND RE SECURE THE DOORS AND TORN SCREENS LEADING TO THE SUBSTRUCTURE AREAS.

OWNER IS ADVISED TO HIRE AN APPROPRIATE TRADES PERSON TO POWER WASH THE DECK, MAKE FURTHER INSPECTION AND REMOVE AND REPLACE ALL ROT DAMAGED WOOD MEMBERS FOUND.

OWNER IS ADVISED TO HIRE AN APPROPRIATE TRADES PERSON TO REMOVE AND REPLACE ALL ROT DAMAGED WOOD MEMBERS FOUND IN THE STAIRS.
