**Property Address:** 15500 Bodega Hwy  
Mountain View, CA 94922

# WIN Home Inspection Extended Home Inspection

**Work Order Number:** 10004145      **Service date:** 08/17/2017      **Time:** 10:00 AM

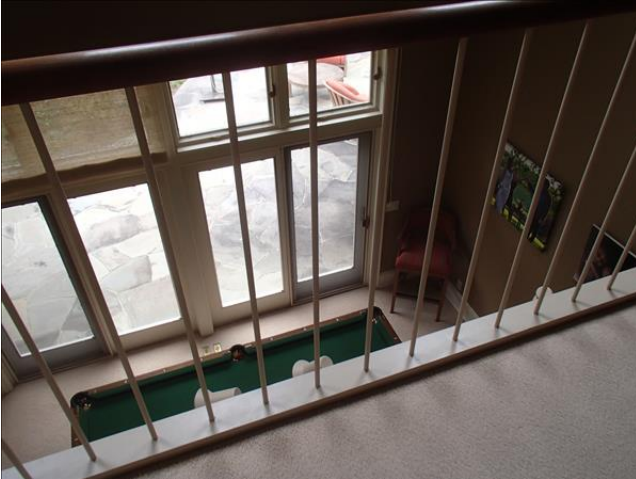
Figure 1

For child safety, new building code requires that guardrails be constructed so that a four-inch ball will not pass through the railing. Consideration should be given to modifying the guardrail at the stairway as a preventive safety measure.

Living Room / Main Hall  
Interior Stairway(s)  
Attention

*For child safety, new building code requires that guardrails be constructed so that a four-inch ball will not pass through the railing. Consideration should be given to modifying the guardrail at the stairway as a preventive safety measure.*

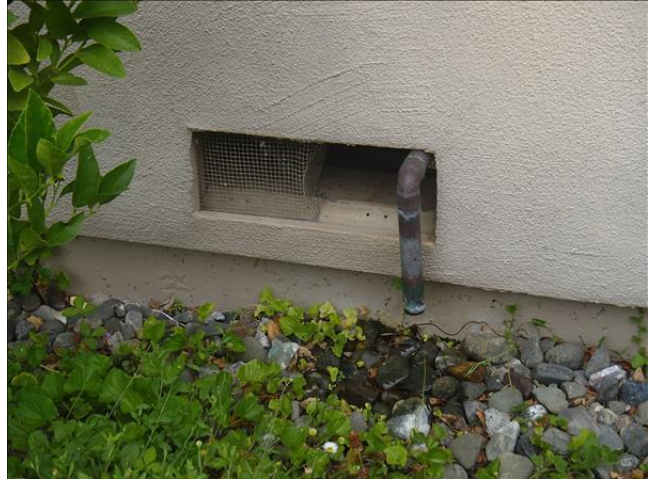
Figure 2

We noted damaged vent screens at the vents for the crawl space. Consult a tradesperson for further evaluation and repair.

Structure Perimeter Exterior  
Vent Screens  
Attention

*We noted damaged vent screens at the vents for the crawl space. Consult a tradesperson for further evaluation and repair.*

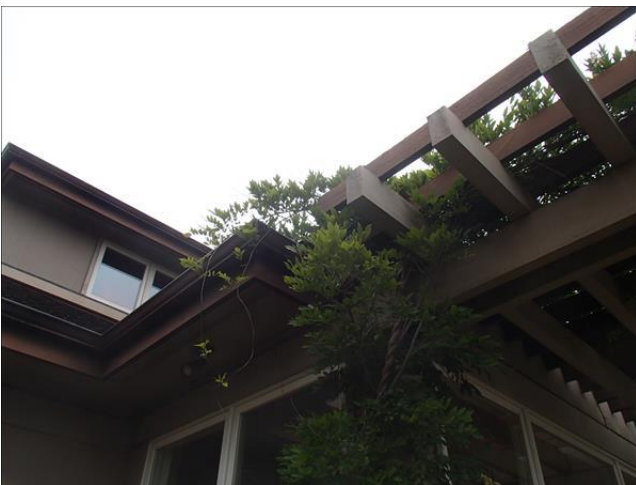
Figure 3

There is vegetation growing up against the exterior surface material. All vegetation should be trimmed at least 6-12 inches away from the structure to eliminate a common avenue for pest infestation and damage to the exterior structure material.

Structure Perimeter Exterior  
Vegetation Clear from Structure  
No

*There is vegetation growing up against the exterior surface material. All vegetation should be trimmed at least 6-12 inches away from the structure to eliminate a common avenue for pest infestation and damage to the exterior structure material.*

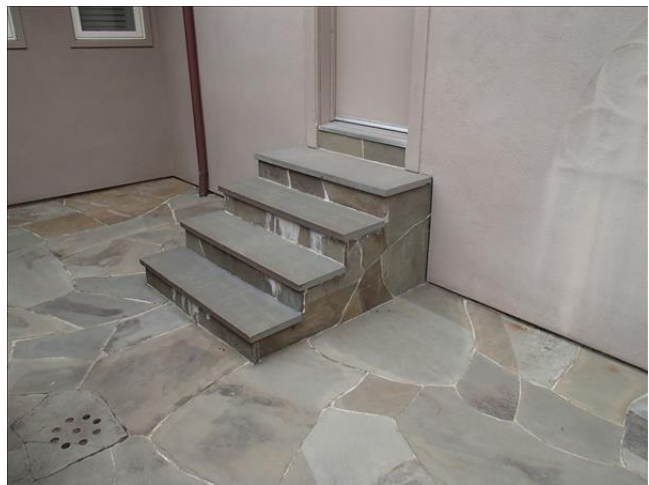
Figure 4

Consideration should be given for installing a railing at the landing off of the garage for safety.

Patios/Decking/Porches  
Railings  
Attention

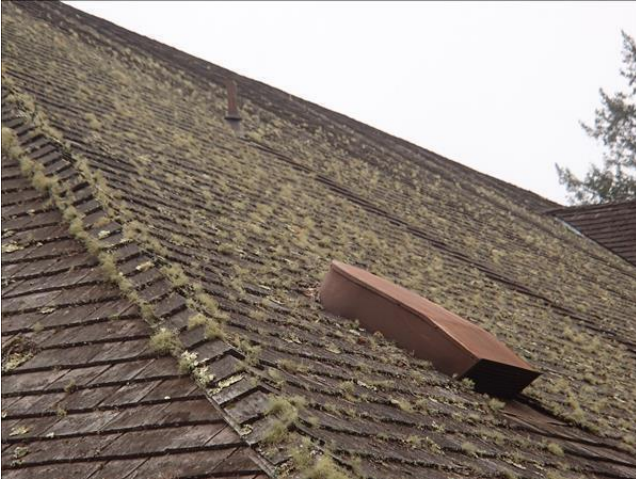
Figure 5

It is suggested that any moss or fungi growth on a roof be removed. The roof should be treated to prevent regrowth.

Roof  
Moss/Mildew  
Attention

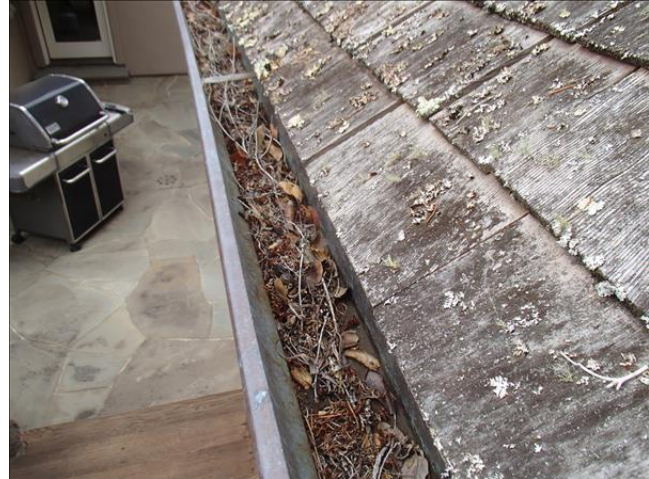
Figure 6

There is debris build up in the gutters that should be removed. Debris can clog the gutters, down spouts, and/or drain system if not cleaned out. Cleaning the gutters on an annual basis is recommended for proper care.

Roof  
Gutters / Down Spouts  
Maintenance - Debris build up

*There is debris build up in the gutters that should be removed. Debris can clog the gutters, down spouts, and/or drain system if not cleaned out. Cleaning the gutters on an annual basis is recommended for proper care.*

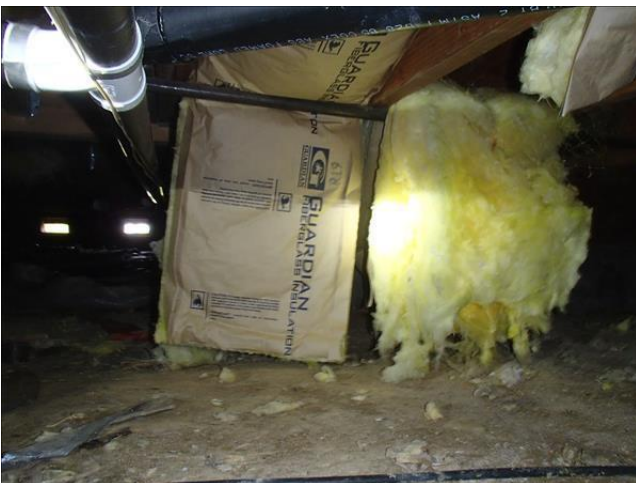
Figure 7

There are fiberglass insulation battens in the crawl space area that have fallen. We recommend re-installing them.

Raised Foundation  
Insulation  
Batten Insulation

*There are fiberglass insulation battens in the crawl space area that have fallen. We recommend re-installing them.*
